# Manhole Inspection Summary

## Manhole # S13SS\_035MH

Insp Date: **7/24/09 10:18 AM**

**Location** Address: **2731 DUKELAND**

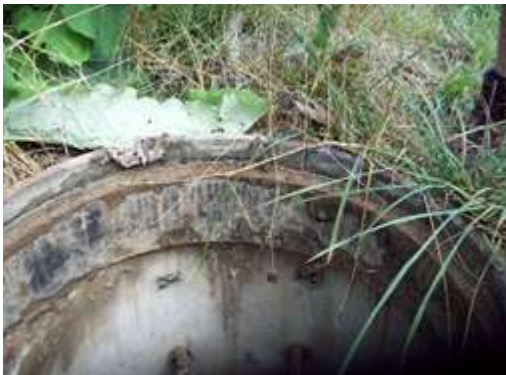
Defect 3

**Steps** Count: **21** Missing: **1** ☐ Corroded

Missing step

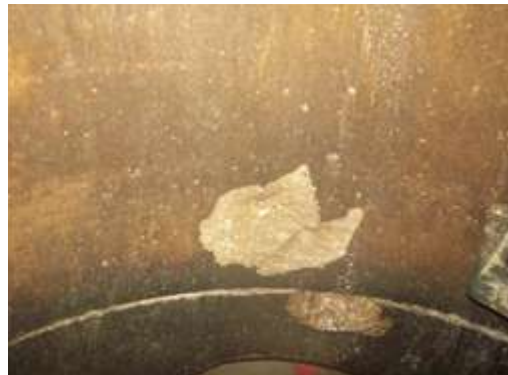
Defect 2

Condition: ☐ Sound ☒ **Cracked** ☐ Root Intrusion ☐ Loose Brick ☐ Deteriorated

SPAULING of wall

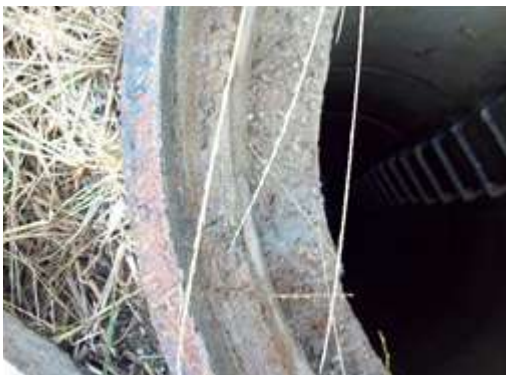
Defect 1

**Frame** Offset: **3** (in.) Condition: ☒ Sound ☐ Cracked ☐ Leaks

FRAME offset 3"

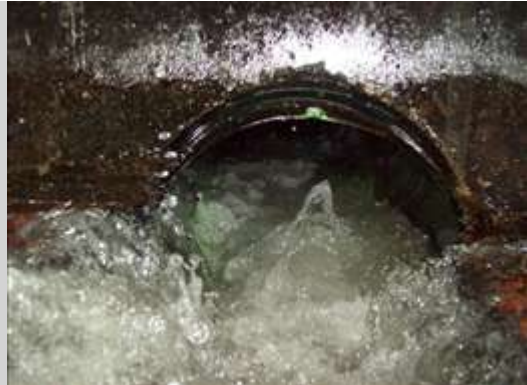
12 O'Clock Outflow

15 in. Circular Gravity Sewer  
Pipe Out @ 12 O'Clock

Pipe Height: (in.) Direct  
Pipe Material: **PVC** ☐ Pipe Lined  
Invert Depth: **25.00** (ft.) Flow Characteristics: **Turbulent**  
Deposits: ☒ None ☐ Mud ☐ Sludge ☐ Debris ☐ Grease  
Silt Depth: (in.) Deposits Extent:  
Infiltration: **None** Pipe Seal Cond: **Sound**

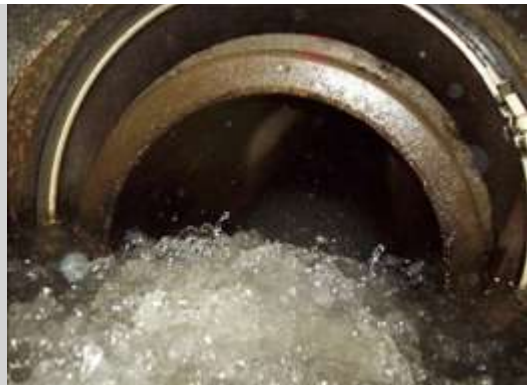
5 O'Clock Inflow

Comments **IS A TERMINAL MH, EXTRA PIPE IN AT 5 IS FROM LAKE ASHBURTON PUMP STATION. INSPECTION COMPLETE**

18 in. Circular Gravity Sewer  
Pipe In @ 5 O'Clock

Pipe Height: (in.) Direct  
Pipe Material: **Clay** ☐ Pipe Lined  
Invert Depth: **23.97** (ft.) Flow Characteristics: **Turbulent**  
Deposits: ☒ None ☐ Mud ☐ Sludge ☐ Debris ☐ Grease  
Silt Depth: (in.) Deposits Extent:  
Infiltration: **None** Pipe Seal Cond: **Sound**
